STABILITY OF THIN PRECAST CONCRETE WALL PANELS SUBJECTED TO GRAVITY AND SEISMIC FORCES

A thesis submitted in partial fulfillment of the
requirements for the degree of
Master of Civil Engineering
at the
University of Canterbury,
Christchurch, New Zealand

Methee Chiewanichakorn

November, 1999

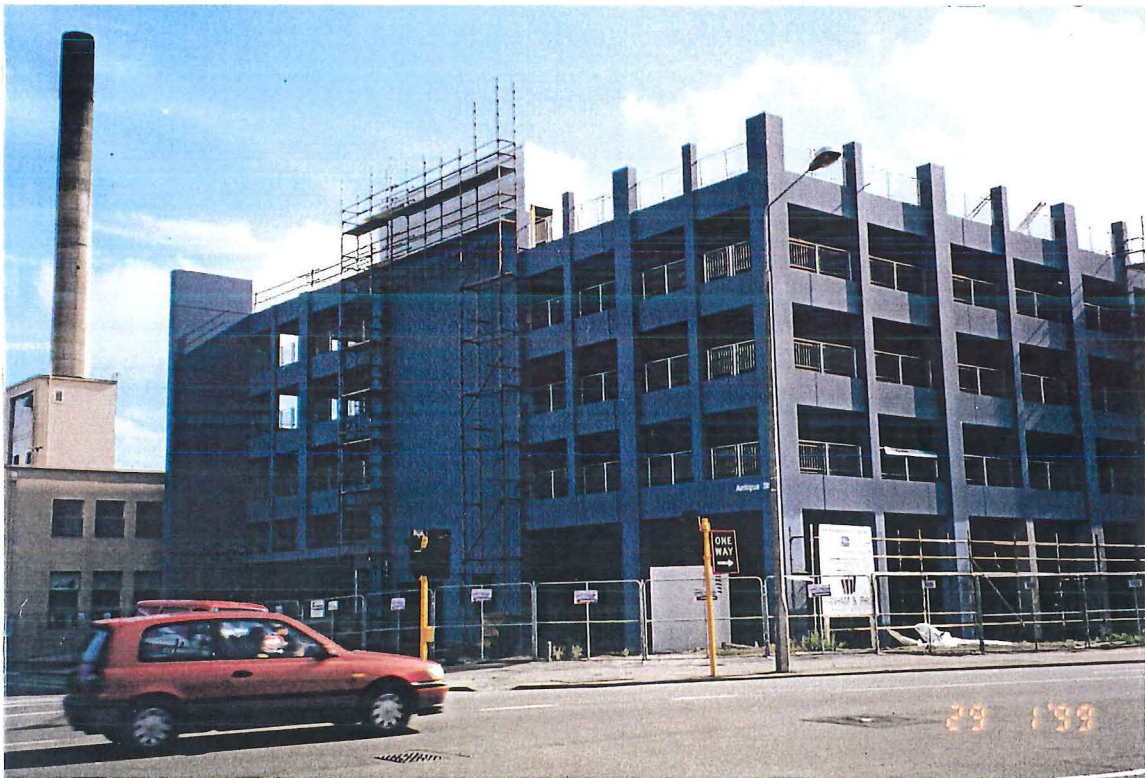
Figure 1.4: The use of precast concrete wall panel for Christchurch hospital car-park building

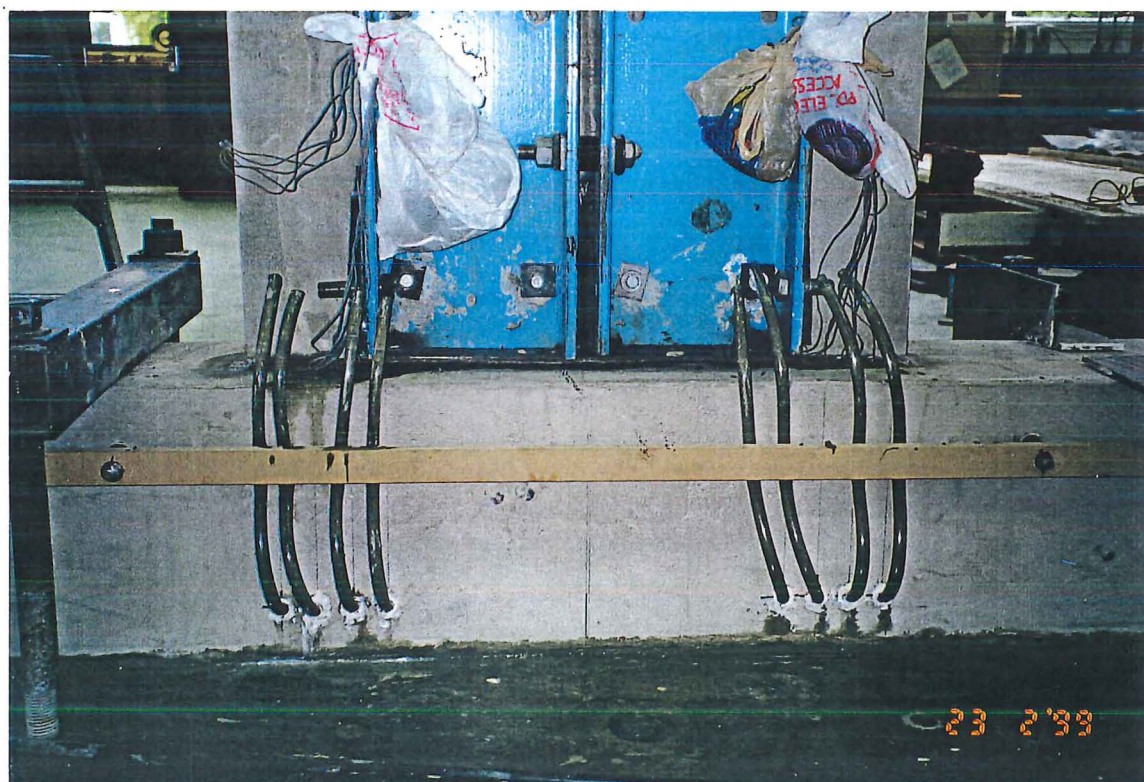
Figure 4.15: Grouting of starter bars at the horizontal connection

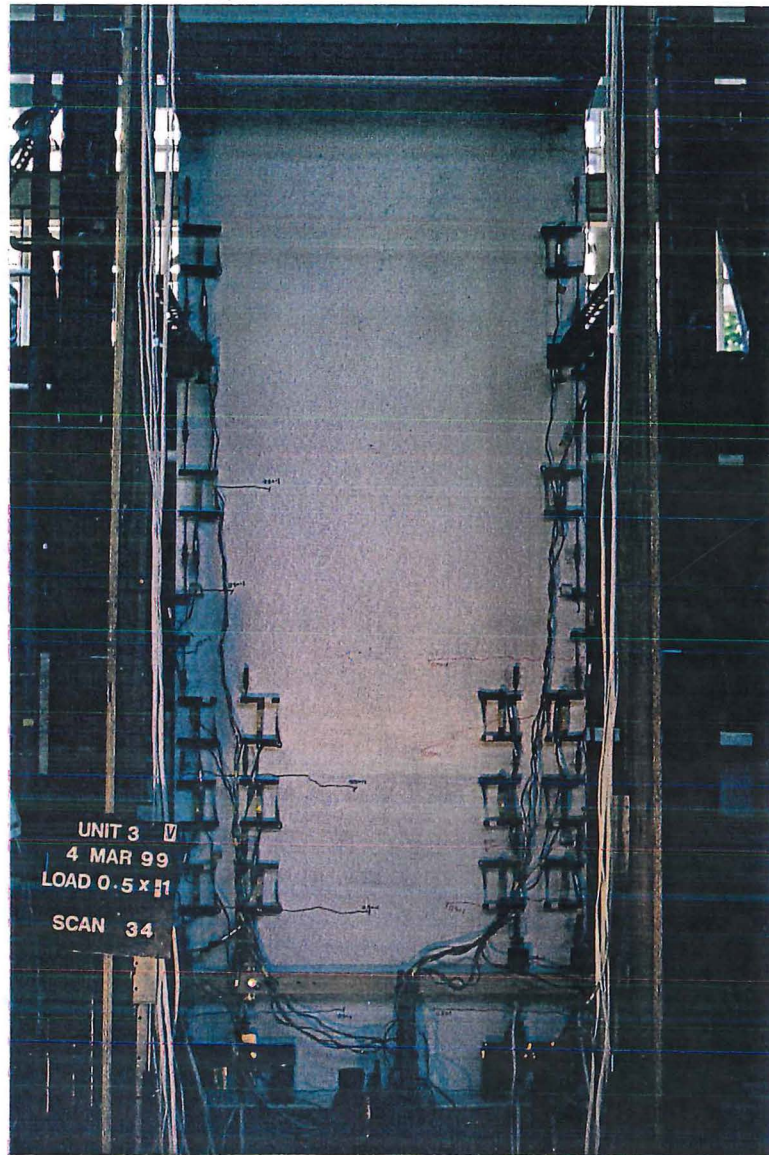
Figure 5.85: View of Unit 3 at cracking strength (South/Concave)

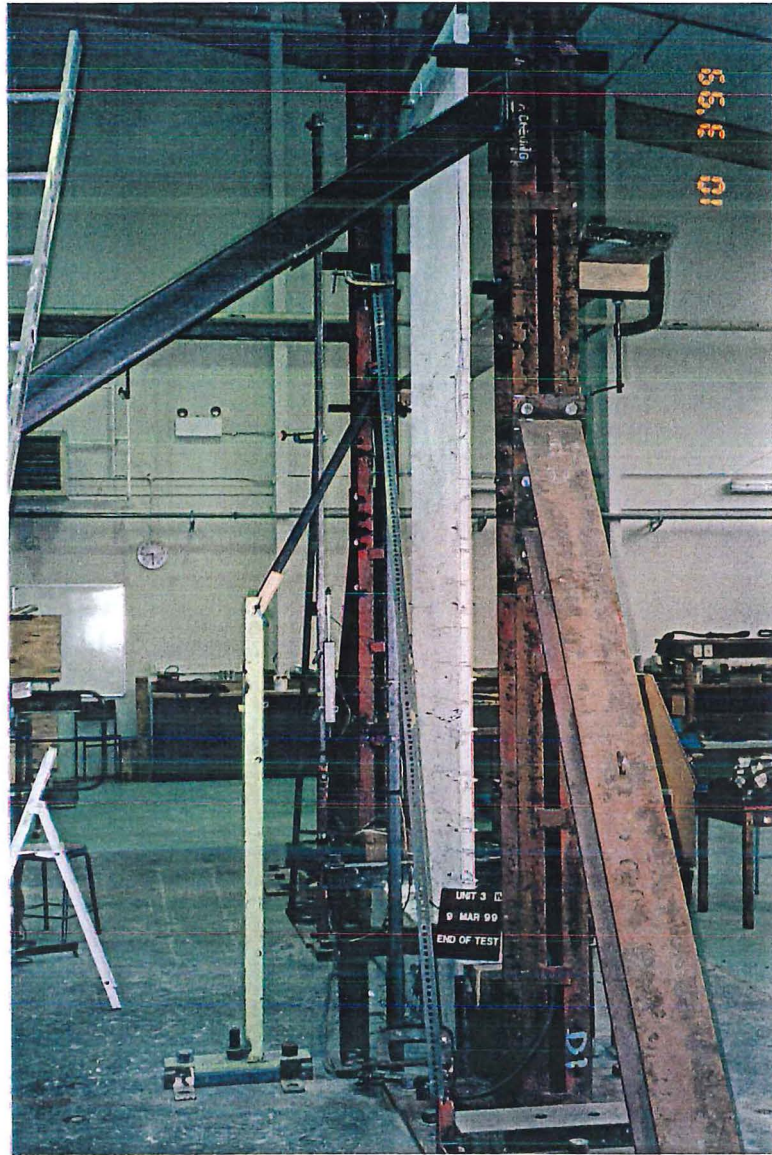
Figure 5.98: Unit 3: West edge view at the end of test

At the end of the test, it was noticed that most cracks were concentrated in the region next to the wall-foundation connection. There was very a small number of cracks in the top half of the wall (see Figures 5.96 to 5.99).

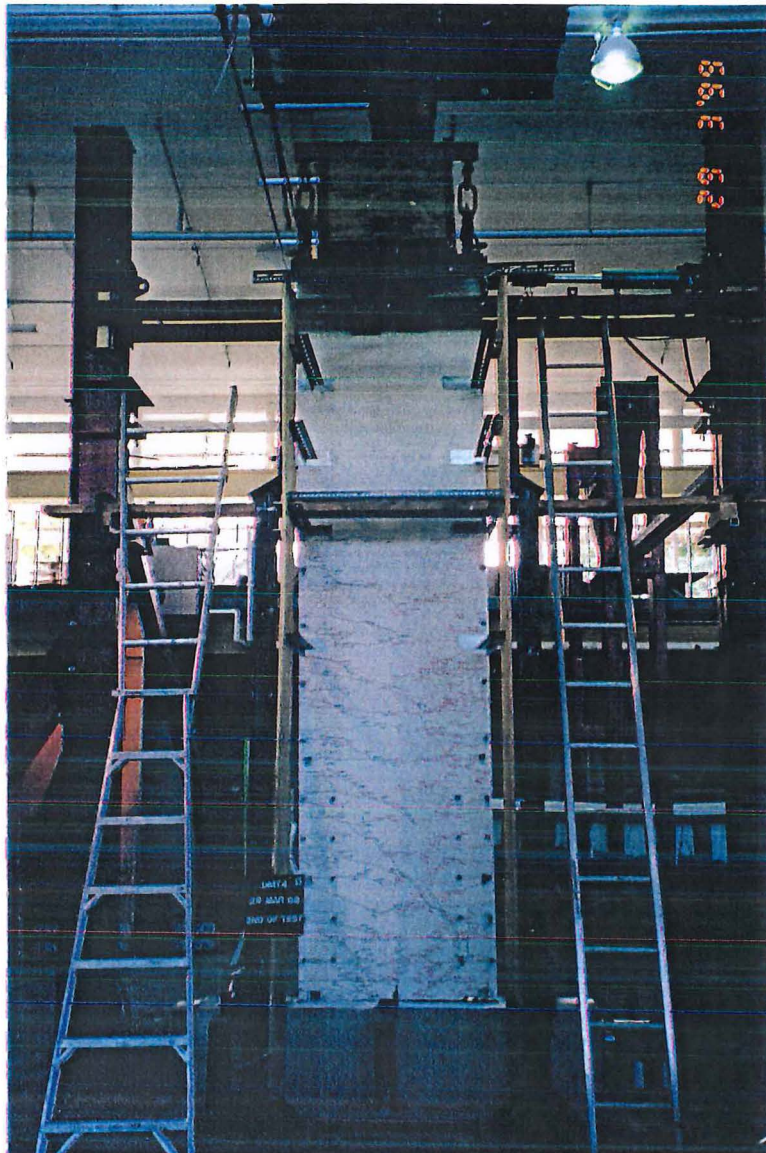
Figure 5.140: Unit 4: Overall cracking pattern on the South/Concave side at the end of test

The test continued until the starter bars fractured at $\mu_{\Delta} = +5.5 \times 1$. Fracture failure occurred at the end of the welds where the starter bars were subjected to cyclic loading (see Figures 5.138 and 5.138). This caused by the retensioning and buckling of the starter bars. Again, it is important to note that this only happened on the East edge of the wall. Neither crushing, spalling of concrete nor fracturing of the starter bars occurred on the West edge of the wall. Overall cracking patterns are shown from Figures 5.140 to 5.142.
